All Saints Church, Thirkleby

General Glazing Report

Undertaken for
Carolyn Potter
on behalf of All Saints Church PCC

The inspection of the glazing was carried out on 27 January 2022 from the ground, with the aid of ladders and binoculars, on a dry, bright and cold day.

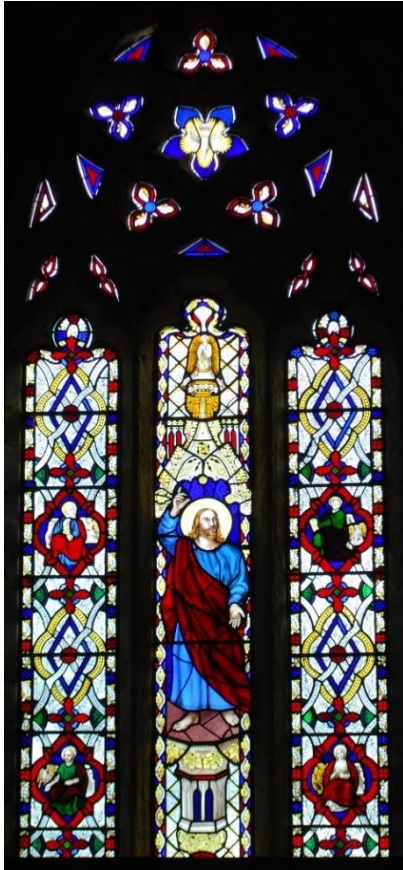
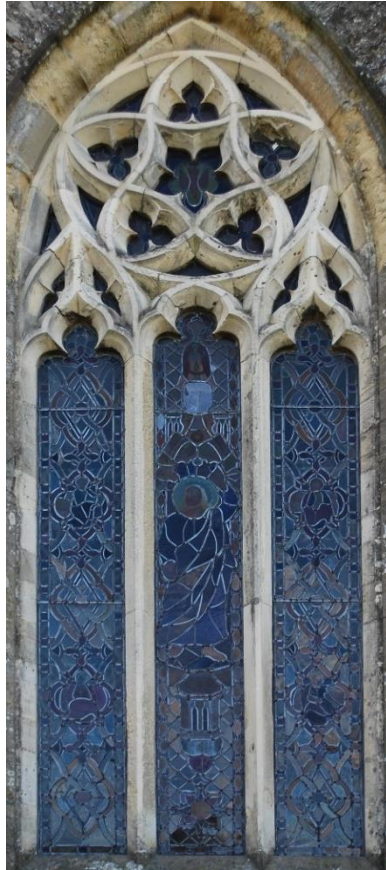
WINDOW NUMBER: I (East)

- Glass: Antique glass, generally in sound condition with occasional fractures; fractured shield held by angel at top of light b has been previously repaired and plated to exterior; surface dirt and cobwebs

- Paint: Grisaille glass paint and silver stain, some fading / loss is evident, especially to foliated background pieces, although most appears to be in sound condition

- Leading: Mix of 3/16", 1/4", 5/16" convex profile leads, generally sound condition with oxidation noticeable to exterior and browning around solder joints; slight bowing to base of panel b; waterproofing compound appears sound

- Supports: 1/2" round profile support bars, 6 per outer light, 5 per centre light including 2 shaped bars in 3/8" round profile, mostly non-ferrous and in sound condition; copper wire ties, sound condition

- Fixing: Dark cement-rich mortar, generally sound condition with some losses to left jamb to interior
- Protection: None

- **This window is structurally in sound condition but shows some fading and loss of painted detail**
- **Careful clean in situ, paint non-ferrous support bars**
- **Longer term, and should the window need to be removed to facilitate any stonework repairs, the installation of environmental protective glazing (EPG) to preserve the painted detail should be considered.**

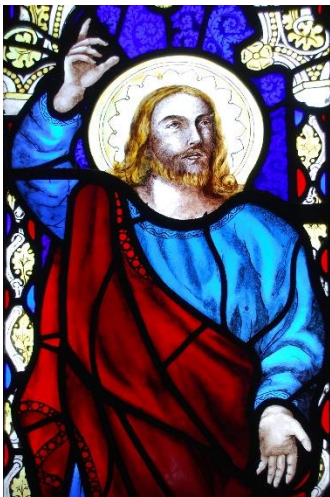
Detail, light b, painted detail in sound condition

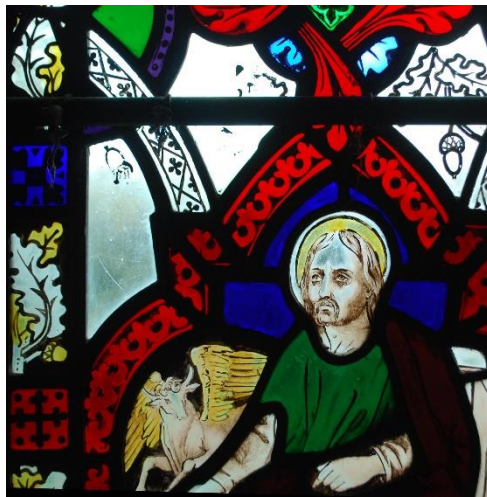
Detail, base of light a, faded and lost painted detail

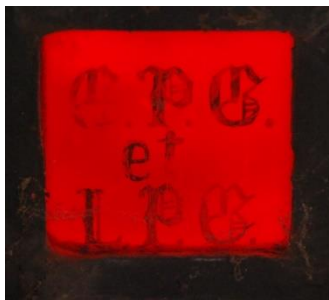
Detail, base of light b: initials and date (much faded)

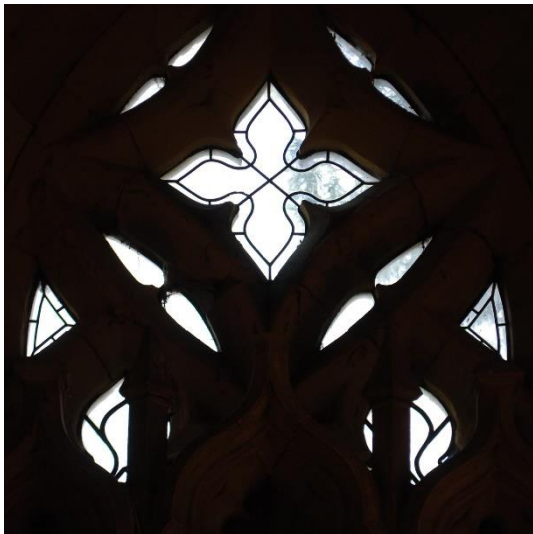
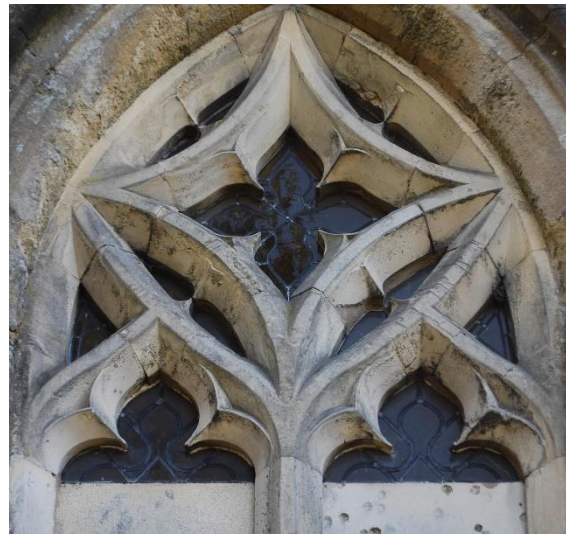
WINDOW NUMBER: sII

- Glass: Antique glass, generally sound condition with occasional fractures; much surface dirt and cobwebs
- Paint: None
- Leading: 3/8" flat profile to heads and 1/4" flat profile to tracery, weak but stable condition; waterproofing compound appears sound
- Supports: None
- Fixing: Mortar, crumbling with losses especially around heads
- Protection: None

- **General clean in situ**
- **Rake out mortar and re-point to exterior.**

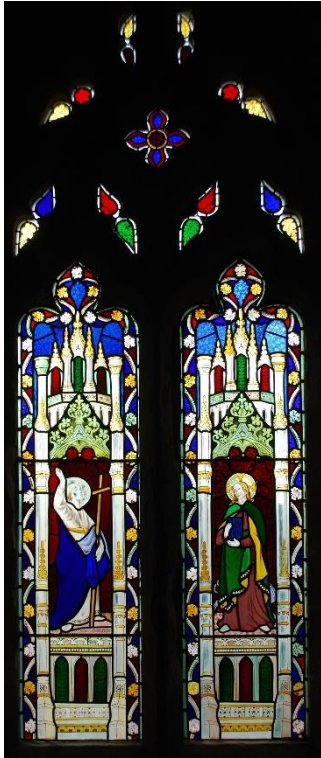
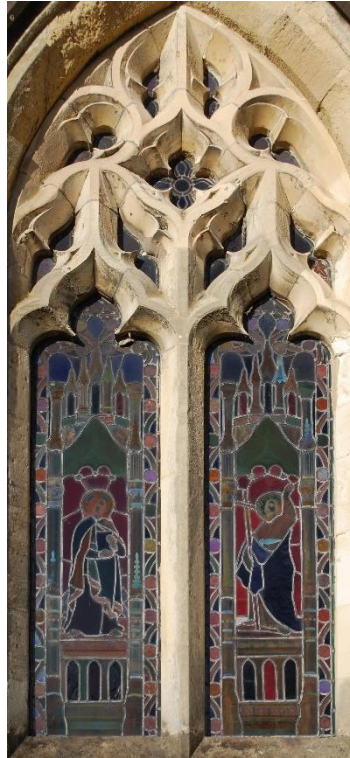
WINDOW NUMBER: sIII

- Glass: Antique glass, generally in sound condition with occasional fractures; surface dirt and cobwebs
- Paint: Grisaille glass paint and silver stain, some fading evident but generally stable condition
- Leading: Mix of 3/16" and 1/4" flat profile, weak with some fractures and slight bowing / flexing to light b
- Supports: 5/16" round profile support bars, 2 per light (too widely spaced, offering insufficient support), rusted but sound condition; copper ties, sound condition
- Fixing: Dark grey cement-rich mortar, some losses, especially to heads of lights where damage / erosion to surrounding stonework has caused daylight gaps
- Protection: None

- **This window is in a weak condition and some intervention is likely to be necessary within the next 20 – 30 years; the installation of environmental protective glazing (EPG) should be considered to avoid re-leading and to preserve as much original fabric as possible**
- **Careful clean in situ, paint support bars**
- **Rake out mortar around heads and re-point in lime mortar.**

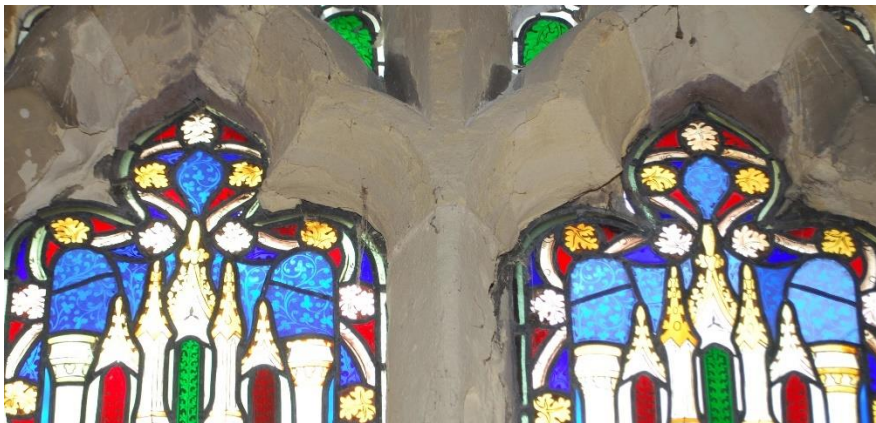
Detail, heads of lights where stonework is damaged and mortar lost

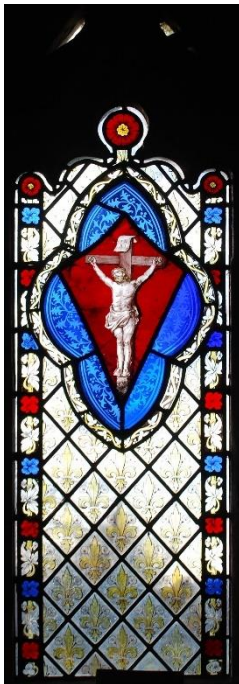
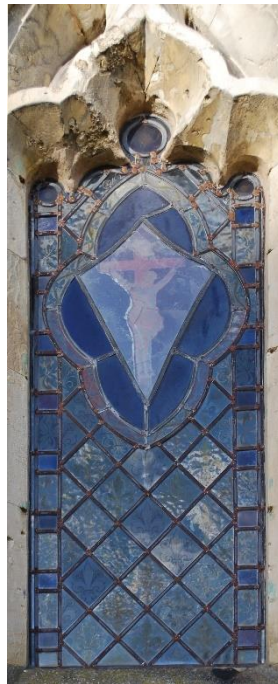
WINDOW NUMBER: sIV

- Glass: Antique glass, generally sound condition; central Crucifixion scene has been previously repaired and plated to both sides with some evidence of water ingress; right eyelet badly fractured and filled with putty; surface dirt and cobwebs
- Paint: Grisaille glass paint and silver stain, sound condition
- Leading: Mix of 3/16" and 1/4" flat profile, sound condition with oxidation of lead to exterior and browning of solder joints, especially to uppermost section; waterproofing compound appears sound
- Supports: 1/4" round profile, 3 no., bent to follow design lines, rusted but sound condition; copper wire ties, sound condition
- Fixing: Lime mortar, sound condition
- Protection: None

- **General clean in situ, paint support bars.**

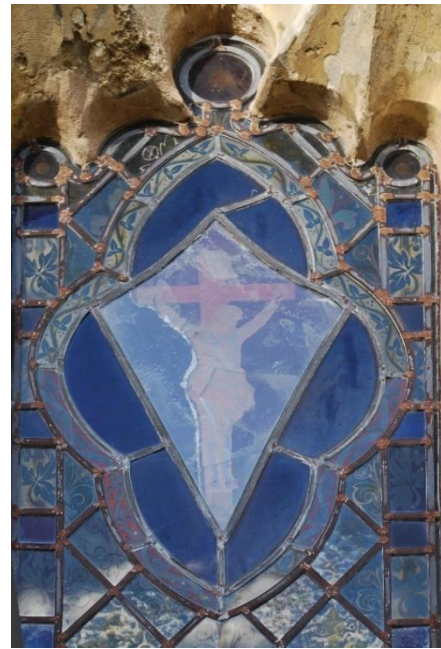
Detail from exterior: plated central figure and browning of solder joints

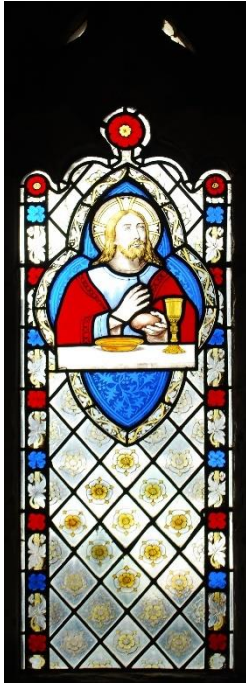
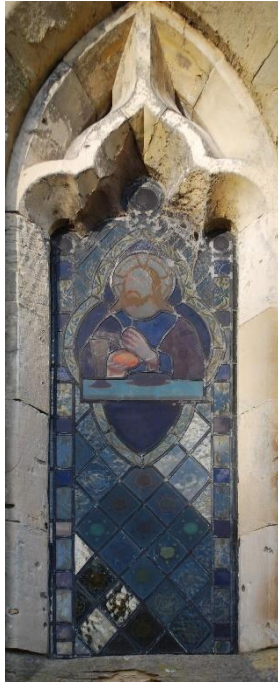
WINDOW NUMBER: sV

- Glass: Antique glass, generally sound condition with occasional fractures; surface dirt and cobwebs
- Paint: Grisaille glass paint and silver stain, some fading evident but generally stable condition
- Leading: Mix of 3/16" and 1/4" flat profile, weak condition with oxidation of lead to exterior and substantial bowing of lower section; waterproofing compound appears sound
- Supports: 1/4" round profile, 2 no., bent to follow design lines, rusted but sound condition; middle bar appears never to have been installed as copper wires are present but unused; copper wire ties, sound condition
- Fixing: Mortar, some cracking and losses, especially at base
- Protection: None

Stained glass window sV is also in weak condition, with significant buckling to the lower section; this window should be removed, dismantled and re-leaded with lead calme of matching size and profile to the original, and re-fixed with new non-ferrous bent support bars.

- This window is in a weak condition with significant bowing of the lower section
- It should be removed, dismantled and re-lead with lead calme of matching size and profile to the original, and re-fixed with new non-ferrous bent support bars (to include the middle bar which is currently missing).

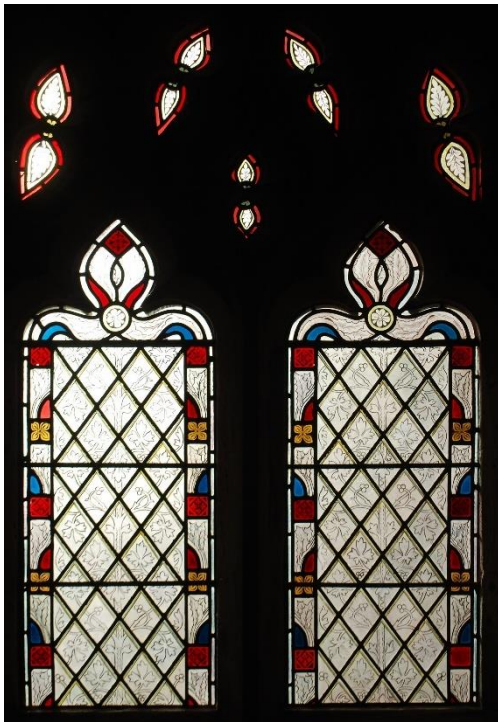
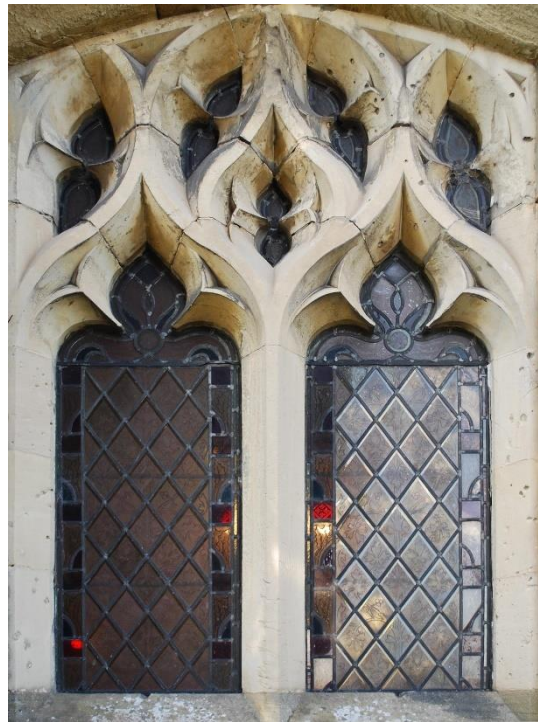
WINDOW NUMBER: sVI

- Glass: Antique glass, sound condition; surface dirt and cobwebs

- Paint: Grisaille glass paint and silver stain, sound condition
- Leading: 1/4" flat profile lead, sound condition; waterproofing compound appears sound
- Supports: 5/16" round profile support bars, 3 no. per light, rusted but sound condition; copper wire ties, sound condition
- Fixing: Cement-rich mortar, some cracks but generally sound condition
- Protection: None

- **General clean in situ, paint support bars.**

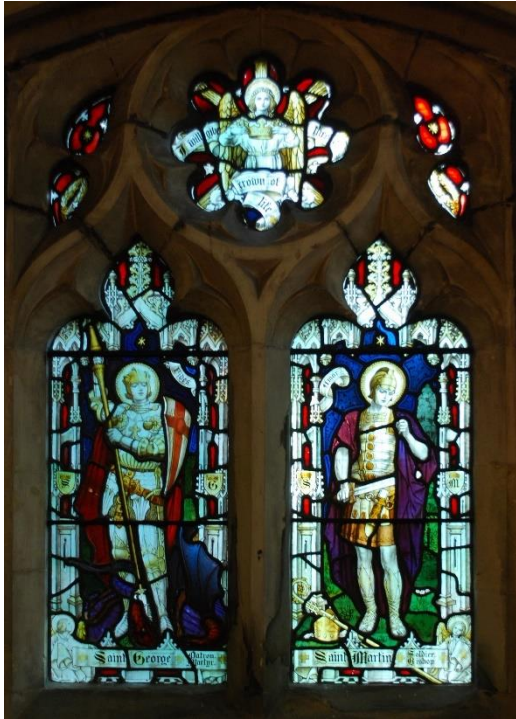
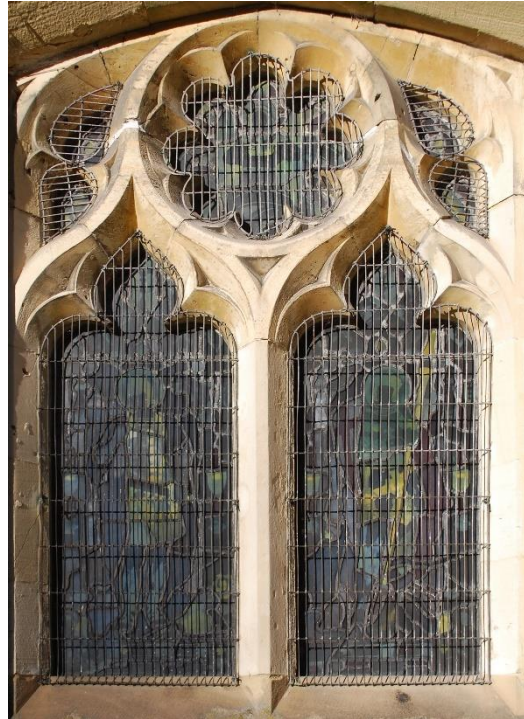
WINDOW NUMBER: sVII

- Glass: Antique glass in good condition; surface dirt and cobwebs
- Paint: Grisaille glass paint and silver stain in good condition
- Leading: Mix of 3/16" and 1/4" convex profile lead, good condition; waterproofing compound appears sound
- Supports: 5/16" square profile support bars, 2 no. per light, rusted but sound condition; copper wire ties in sound condition
- Fixing: Cement-rich mortar, sound condition
- Protection: Wire guards, rusting but sound condition

- **General clean in situ, paint support bars.**

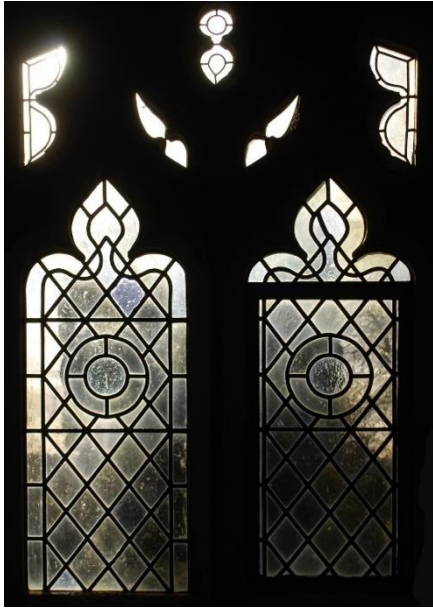
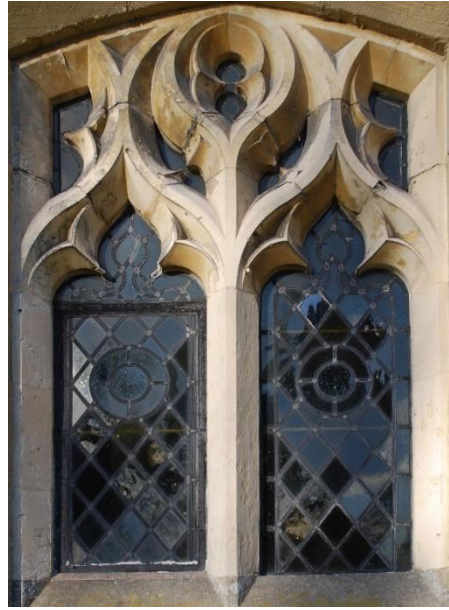
WINDOW NUMBER: sVIII

- Glass: Antique glass, generally sound condition with occasional fractures and previous repairs; surface dirt
- Paint: None
- Leading: 3/8" flat lead, weak condition with slight bowing of panels; waterproofing compound appears sound
- Supports: 3/8" round profile support bars, 2 no. to light a and 1 no. to light b, rusted but sound condition; copper wire ties in sound condition
- Fixing: Mortar, sound condition
- Opener: Metal casement frame to light b, inoperable and sealed in closed position, frame is rusted, previously painted and in sound condition
- Protection: None

- **Although currently stable, this window is in a weak condition and should be considered for re-leading within the next 10-20 years**
- **A new opening casement frame could be considered if desired for ventilation; alternatively the glazing could be adapted into a fixed panel.**

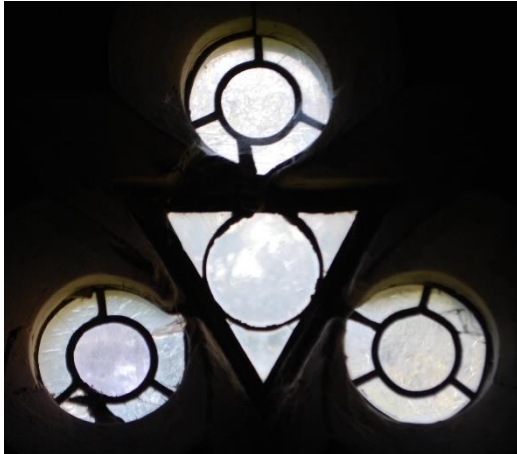
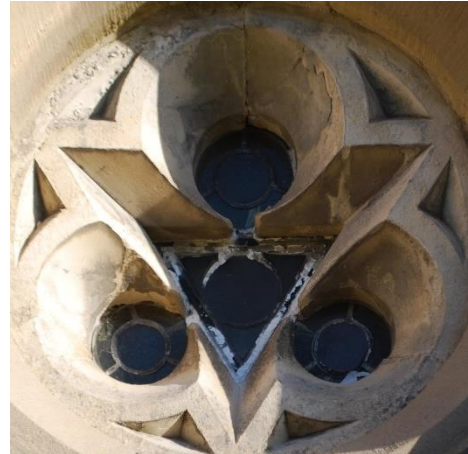
WINDOW NUMBER: SIX (Toilet)

- Glass: Antique glass, generally in sound condition with some fractures, secured with silicone sealant; surface dirt
- Paint: None
- Leading: 1/4" flat profile, weak condition
- Supports: None
- Opener: Metal frame to triangular central section, inoperable and sealed in closed position
- Fixing: Mortar, in sound condition but with losses to stonework to interior
- Protection: None

- **Previous repairs are unsightly but stable; consider removing panels for re-leading if desired to improve the appearance**
- **Otherwise, general clean in situ.**

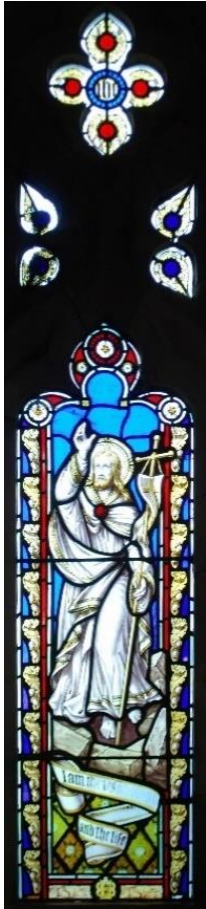
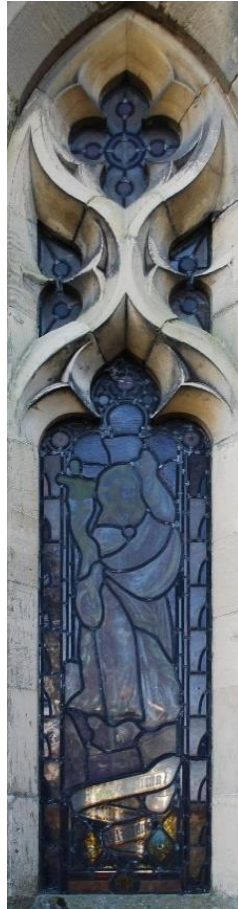
WINDOW NUMBER: n11

- Glass: Antique glass, generally in good condition but with several fractures at base of window and damage / loss to left-most tracery; surface dirt including algae growth and cobwebs
- Paint: Grisaille glass paint and silver stain, generally stable condition but severe fading /loss of inscription text

- Leading: Mix of 3/16" and 1/4" flat profile lead, weak condition; slight gap at shaped division above base panel; waterproofing compound appears sound
- Supports: 5/16" round support bars, 2 no., rusted but sound condition; copper wire ties in sound condition
- Fixing: Mortar, some cracking and losses around heads, otherwise sound condition
- Protection: None

- **This window is in a weak condition, and the growth of algae suggests either water ingress or condensation held on the surface, which has also caused damage to the painted detail**
- **The installation of environmental protective glazing (EPG) to the main light should be considered to avoid re-leading and to preserve as much original fabric as possible**
- **Re-installation with EPG would also allow the restoration of the inscription, by 'cold painting' on the reverse of the glass following the faded original detail**
- **The lower left tracery light should be removed and new painted pieces produced to repair the damaged areas, matching the colour, tone and style of the existing glass.**

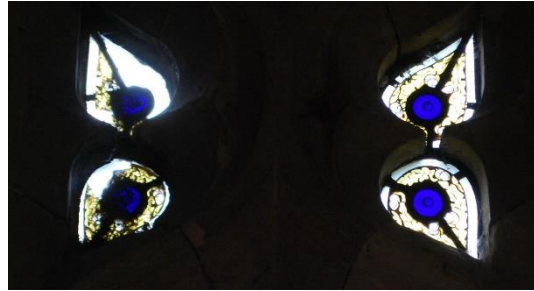
Detail, damage and loss to left-most tracery

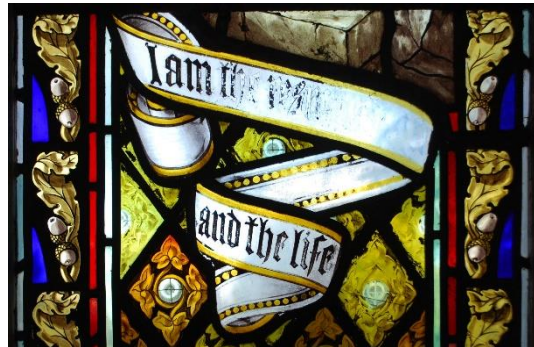
Detail, paint lost to inscription

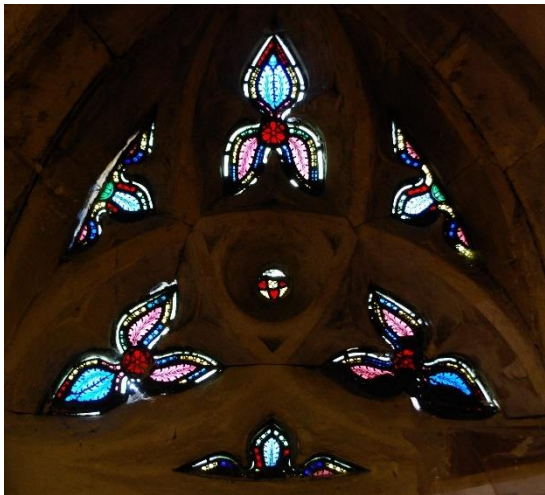
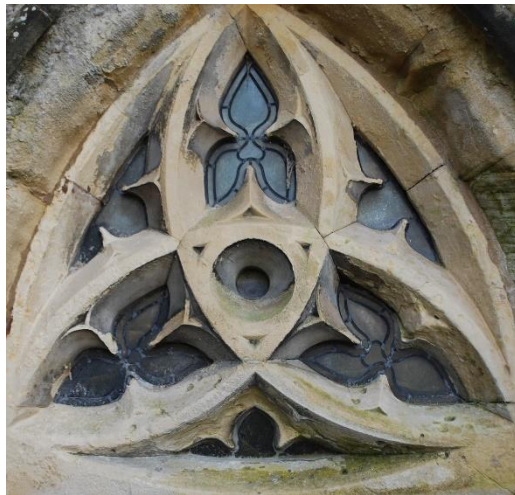
WINDOW NUMBER: nIII (Vestry)

- Glass: Antique glass, generally sound condition with occasional fractures; much surface dirt and cobwebs
- Paint: Grisaille glass paint, sound condition
- Leading: Mix of 3/16" and 1/4" flat profile lead, sound condition; waterproofing compound appears sound
- Supports: None
- Fixing: Mortar in very poor condition with many gaps around panels where stonework is eroded, both interior and exterior, and mortar lost; water outflow pipe to right of window with run-off down the wall appears to be causing damp and damage to the stonework
- Protection: None

Some damage to and erosion of the stonework was noted, especially for window nIII (Vestry) where a water outflow pipe is poorly located; this should be remedied and the stonework assessed by an experienced stonemason. Should the window panels need to be removed to facilitate stonework repairs, it would be prudent to re-lead before reinstatement.

- **The water outflow should be adapted / relocated to take run-off away from the wall; the stonework should then be inspected by an experienced stonemason**
- **Should the window panels need to be removed to facilitate stonework repairs, they should be dismantled and re-leaded in lead calmes of the same widths and profile as the existing lead work before reinstatement with lime mortar**
- **If the panels do not need to be removed for stonework repairs, rake out old mortar and repoint in lime mortar; general clean in situ.**

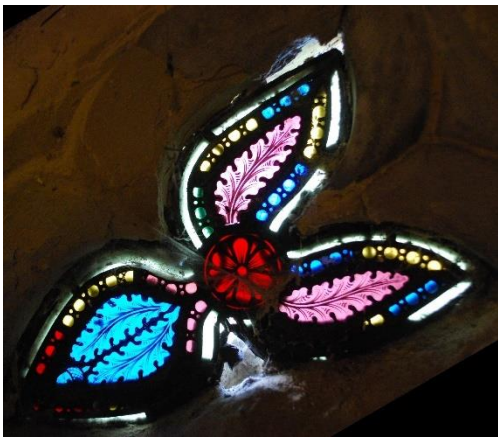
Detail, light gaps due to stonework erosion and mortar loss

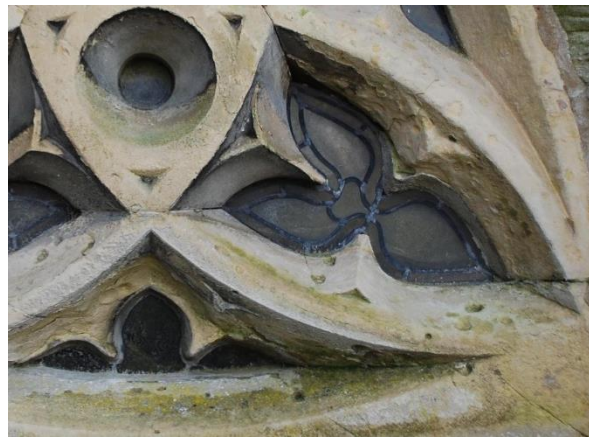
Detail from exterior, stonework erosion and algae growth due to damp conditions

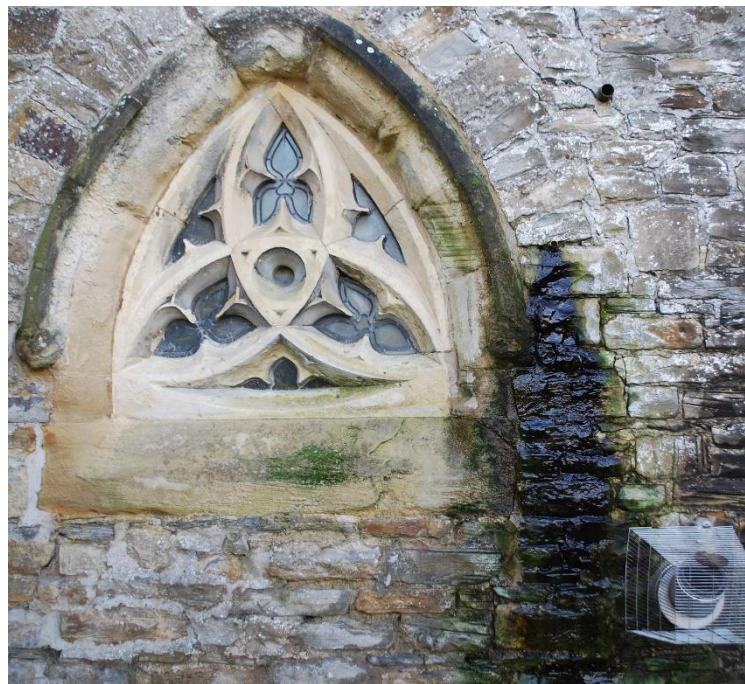
Exterior view, showing outflow to right of window causing damp conditions

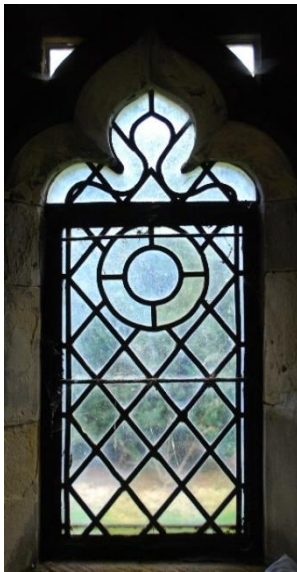
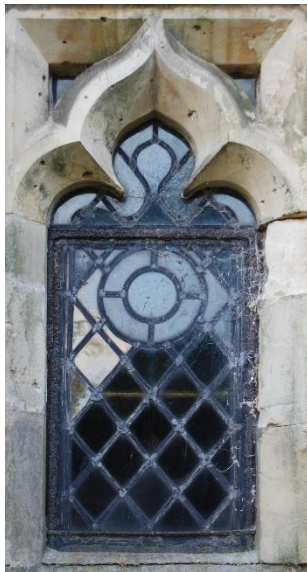
WINDOW NUMBER: nIV (Vestry)

- Glass: Antique glass, generally good condition with occasional fractures, surface dirt and cobwebs
- Paint: None
- Leading: 3/8" flat profile, weak condition with slight bowing at base; unsightly solder joints to exterior (possibly due to previous repairs carried out in situ); waterproofing compound appears sound
- Supports: 5/16" support bar, rusted but sound condition; copper wire ties in sound condition
- Opener: Metal casement frame, inoperable and sealed in closed position, frame is rusted, previously painted and in sound condition
- Fixing: Mortar, sound condition
- Protection: None

- **Although currently stable, this window is in a weak condition and should be considered for re-leading within the next 20 – 30 years**
- **A new opening casement frame could be considered if desired for ventilation; alternatively the glazing could be adapted to a fixed panel.**

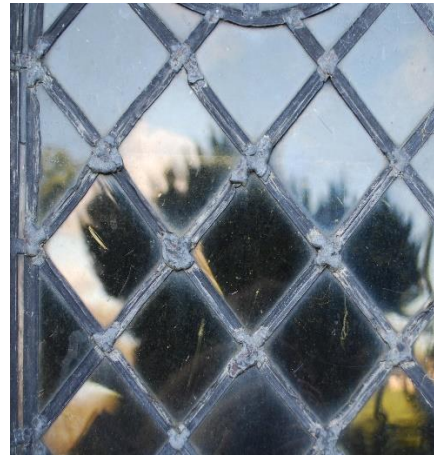
Detail from exterior, unsightly solder joints

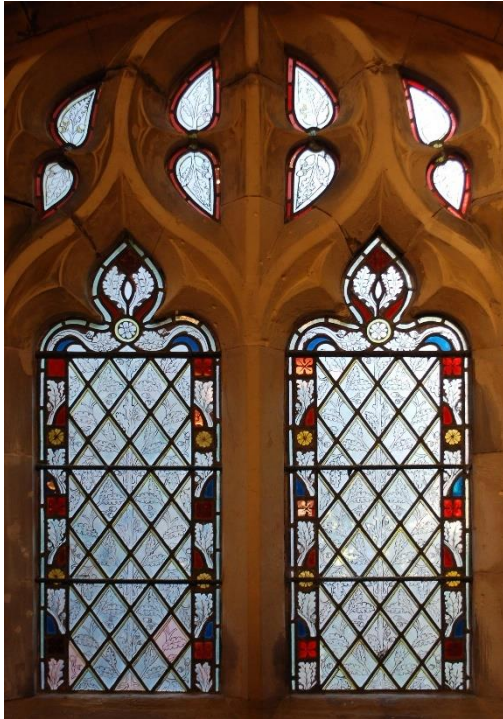
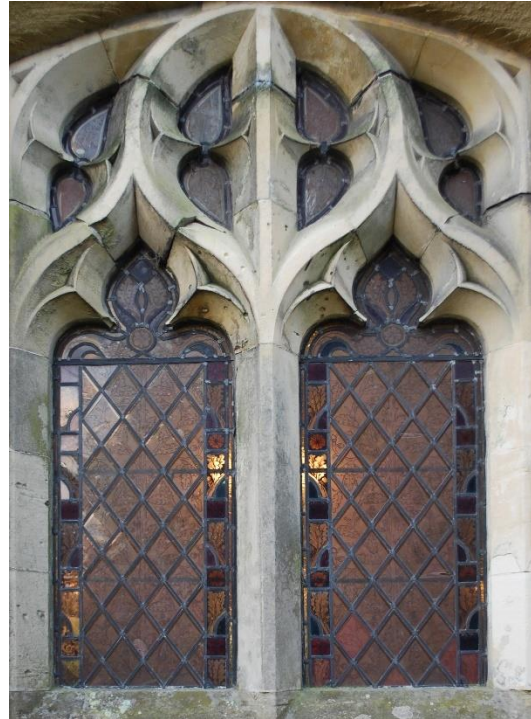
WINDOW NUMBER: nV

- Glass: Antique glass, generally sound condition with occasional fractures; surface dirt and cobwebs
- Paint: Grisaille glass paint and silver stain, sound condition
- Leading: 1/4" flat profile lead, sound condition; waterproofing compound appears sound
- Supports: 5/16" round profile support bars, 3 no. per light, rusted but sound condition; copper wire ties, sound condition
- Fixing: Cement-rich mortar, some cracks but generally sound condition
- Protection: None

- **General clean in situ, paint support bars.**

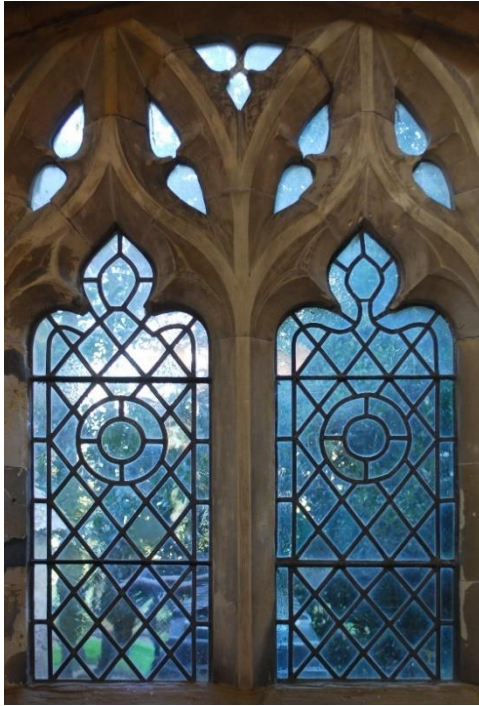
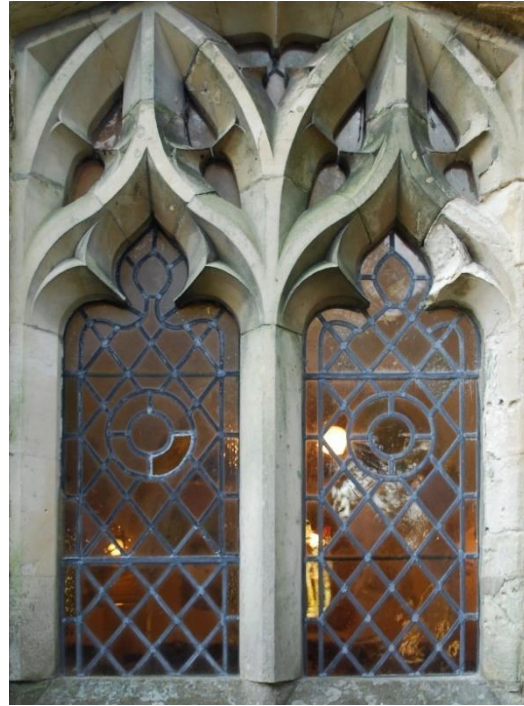
WINDOW NUMBER: nVI

- Glass: Antique glass, generally sound condition; surface dirt and cobwebs
- Paint: None
- Leading: upper part of light b 3/8" flat lead, weak condition; light a and base panel of light b have been previously re-leaded in 3/8" convex profile lead, good condition; putty repair over leadwork in uppermost tracery; waterproofing compound appears sound
- Supports: 5/16" round profile support bars, 2 no. per light a, non-ferrous and good condition to light a, rusted but sound condition to light b; copper wire ties in sound condition
- Fixing: Mortar, generally sound condition
- Protection: None

- **The upper part of light b is in a weak condition and is likely to require re-leading in the next 10-20 years**
- **General clean in situ, paint support bars.**

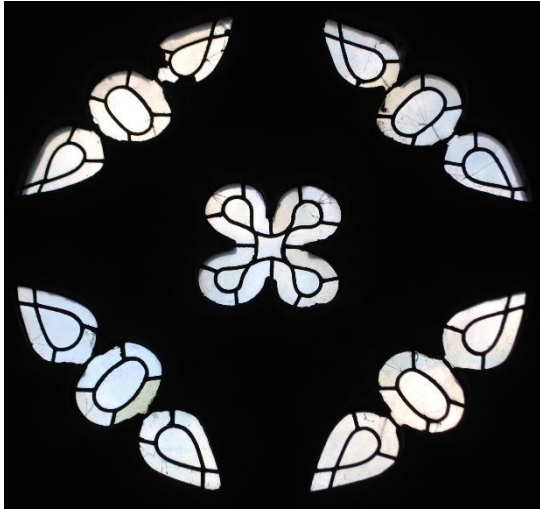
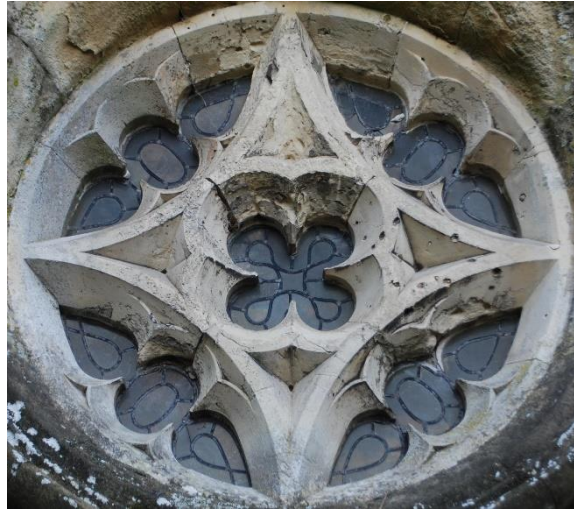
WINDOW NUMBER: nVII (Baptistry)

- Glass: Antique glass with multiple fractures, currently stable or secured with strap leads or putty; surface dirt and cobwebs
- Paint: None
- Leading: 1/4" flat profile, weak condition; waterproofing compound appears crumbly, with some gaps between glass and lead
- Supports: None
- Fixing: Pinkish mortar with cracks and losses; some erosion of stonework to exterior
- Protection: None

- **Although currently stable, this window is in a weak condition and should be considered for re-leading within the next 10-20 years**
- **General clean in situ.**

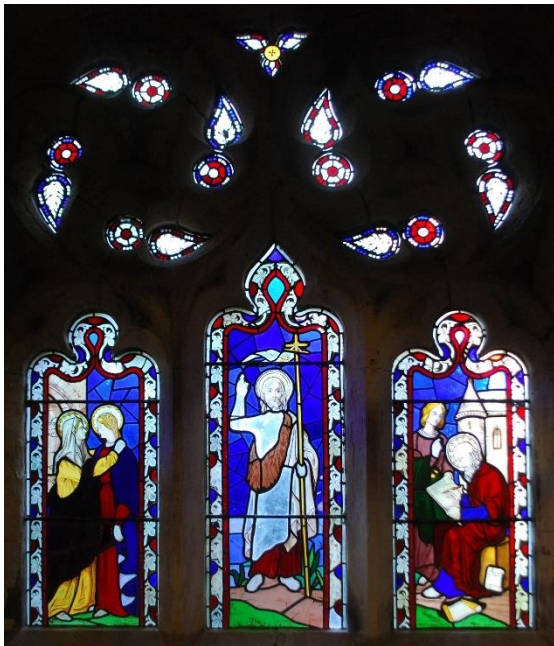
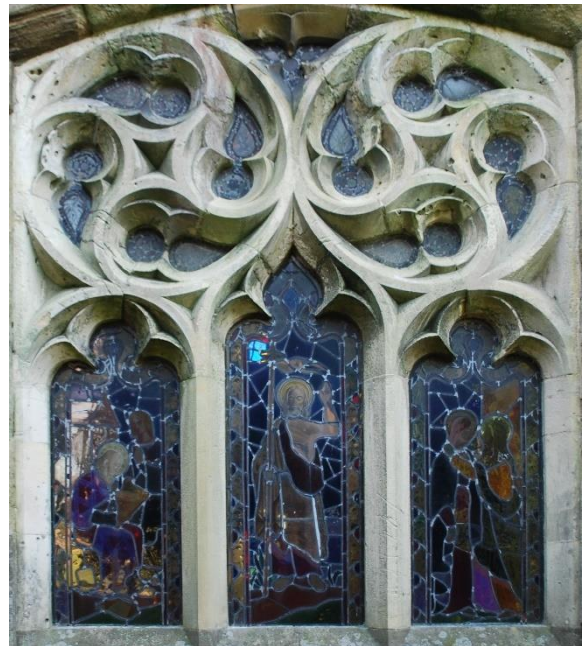
WINDOW NUMBER: nVIII (Baptistry)

- Glass: Antique glass, generally sound condition with occasional fractures and many previous repairs, both painted and unpainted
- Paint: Grisaille glass paint and silver stain, some fading evident but generally stable condition
- Leading: 3/16" and 1/4" flat profile lead, weak condition with damage around previous repairs fitted in situ; waterproofing compound appears sound
- Supports: 5/16" round profile support bars, 2 no. per light, rusted but sound condition; copper wire ties, sound condition
- Fixing: Mortar, generally sound condition with some cracking and previous repair
- Protection: None

- **This window is in a weak condition and its appearance is marred by several poor previous repairs; some fading of painted detail is evident**
- **The installation of environmental protective glazing (EPG) to the main light should be considered to avoid wholesale re-leading and to preserve as much original fabric as possible**
- **Re-installation with EPG would also allow the restoration of key faded details, such as the hand and upper torso of John the Baptist, by 'cold painting' on the reverse of the glass following the faded original detail**
- **Previous unpainted repairs should be replaced with new painted pieces, matching the colour, tone and style of the original glass**
- **Tracery lights: general clean in situ.**

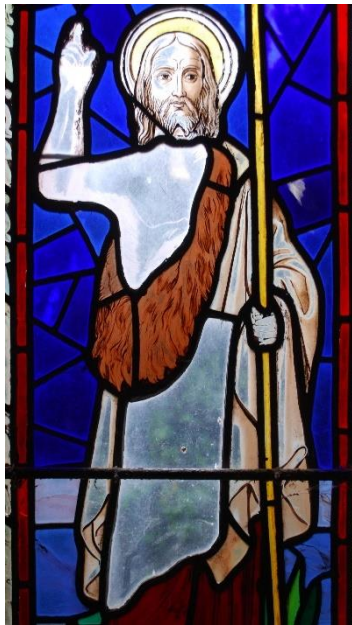
Detail light b, faded paint detail to arm and previous repair in clear unpainted glass

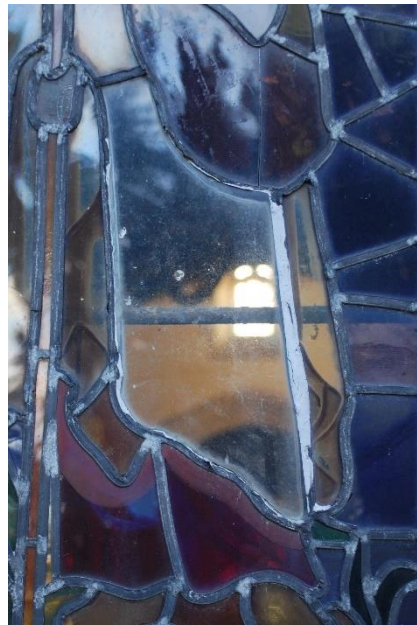
Detail from exterior, previous repair

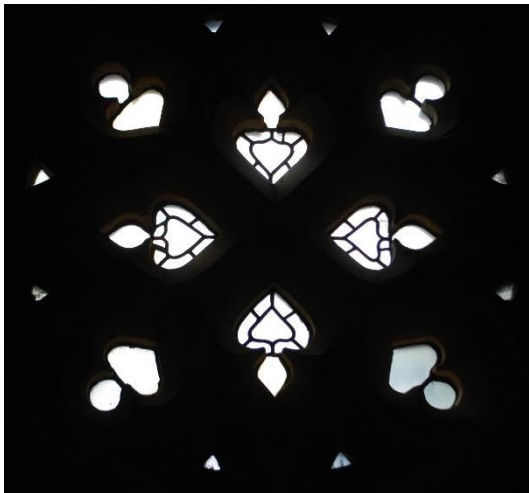
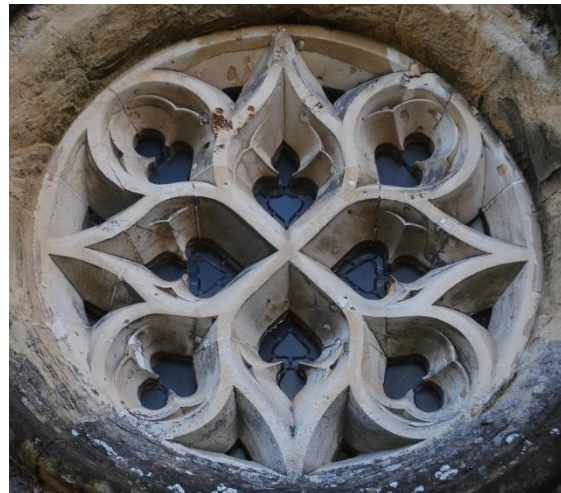
WINDOW NUMBER: nIX (Baptistry)

- Glass: Antique glass, generally sound condition with occasional fractures, all stable or supported with strap leads; surface dirt and cobwebs
- Paint: None
- Leading: 1/4" flat profile lead in weak condition; waterproofing compound appears sound
- Supports: None
- Fixing: Mortar, some cracking but generally sound; some damage to external stone tracery
- Protection: None

- **General clean in situ.**

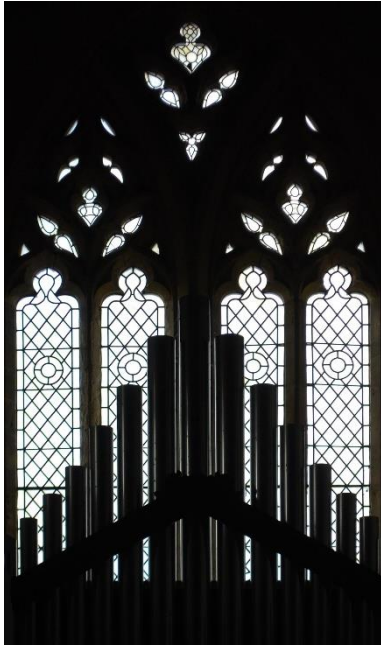
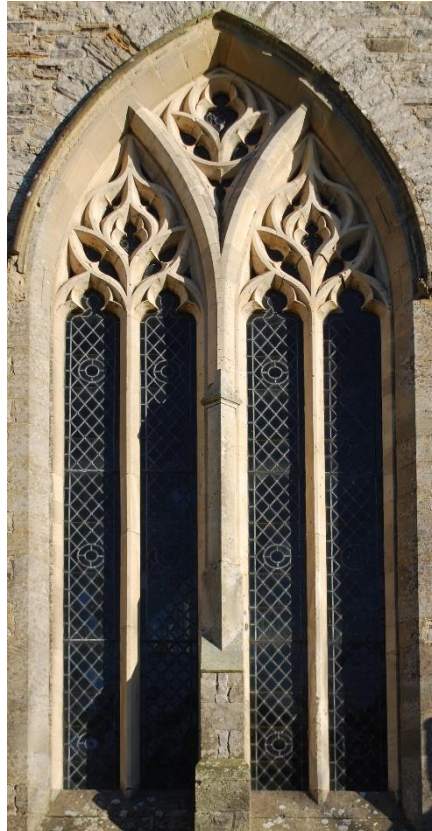
WINDOW NUMBER: w1 (West)

(lower section obscured by organ)

- Glass: Antique glass, generally sound condition; surface dirt and cobwebs
- Paint: None
- Leading: 3/8" flat profile leading, weak condition with signification flex of panels and oxidation to exterior surface; waterproofing compound appears sound
- Supports: 5/16" round profile, 11 no. per light except that 5th bar up is missing from both lights c and d, rusted but sound condition; copper wire ties, sound condition
- Fixing: Mortar, sound condition
- Protection: None

- **Although currently stable, this window is in a weak condition and should be considered for re-leading within the next 10-20 years.**

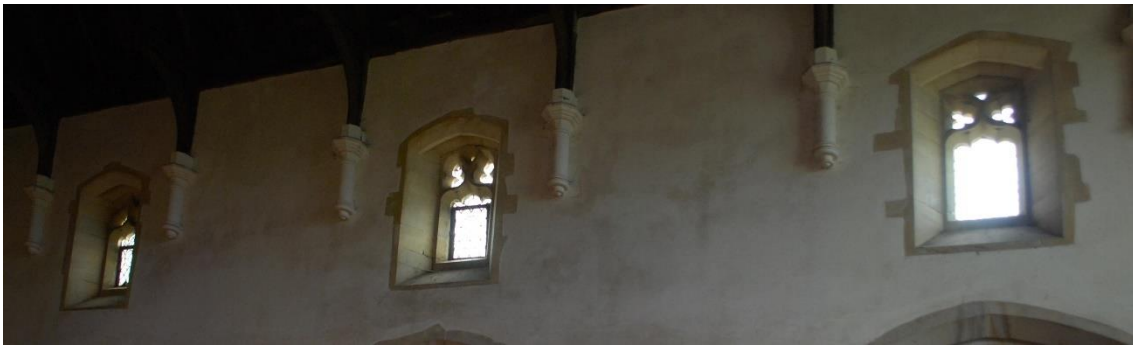
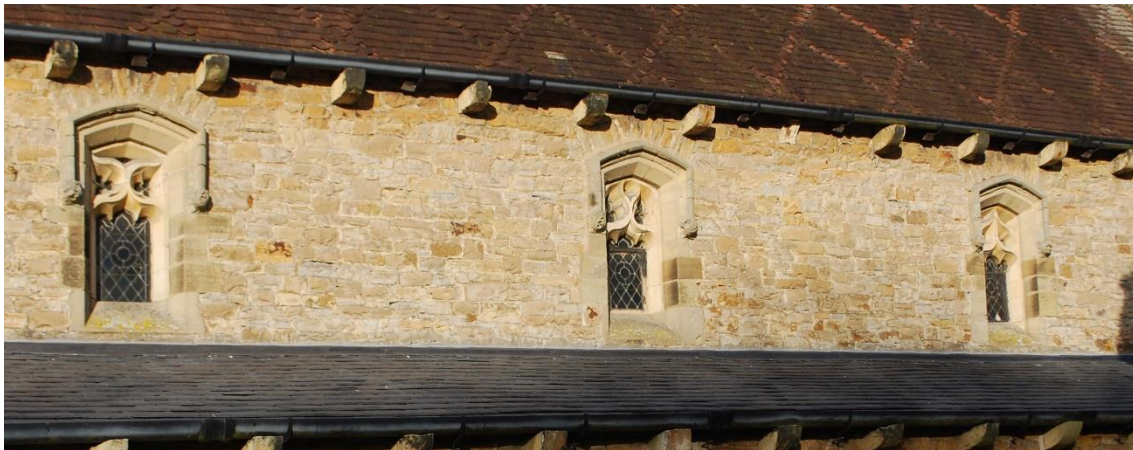
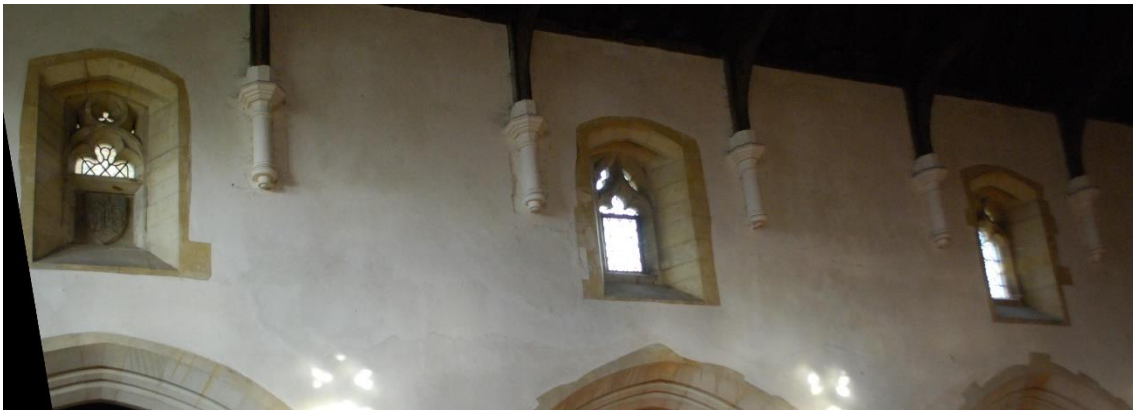
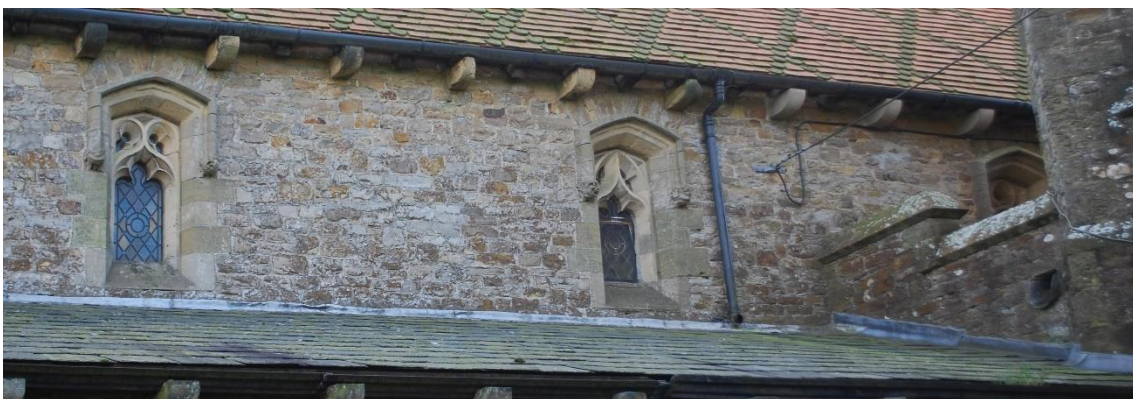
WINDOW NUMBER: Clerestory

- The glazing appears to be currently stable but likely to be in a weak condition, similar to others of the same design (sVIII, nIV, nVI, wI)

- **It would be prudent to undertake a closer inspection of the clerestory windows at such time as access is available to facilitate other works (for example roof inspection / repair).**

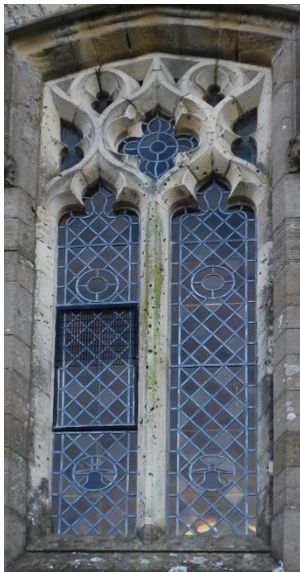
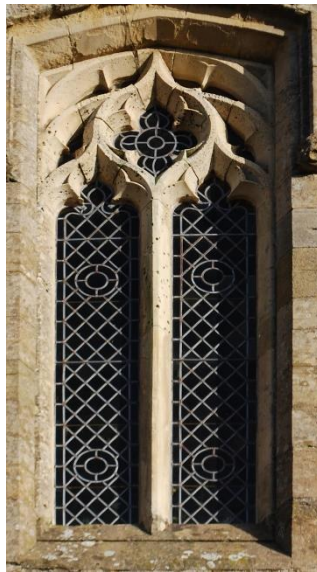
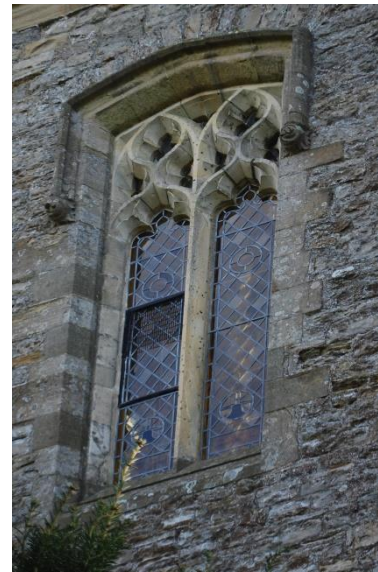
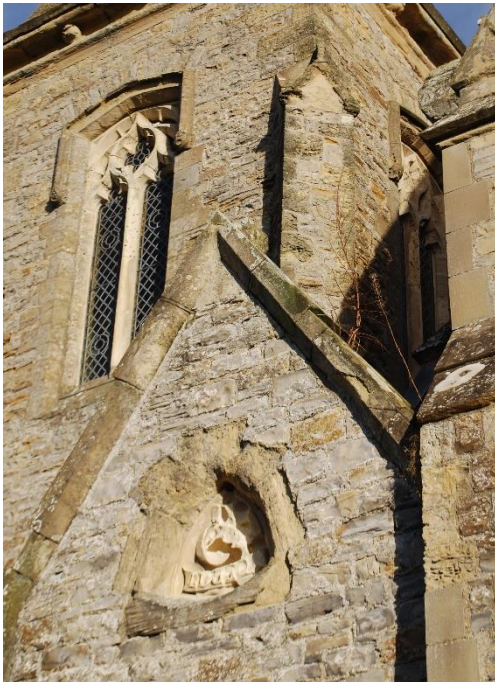
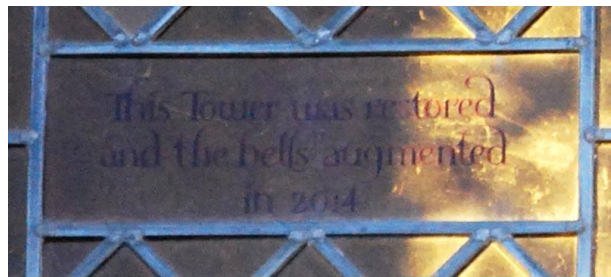
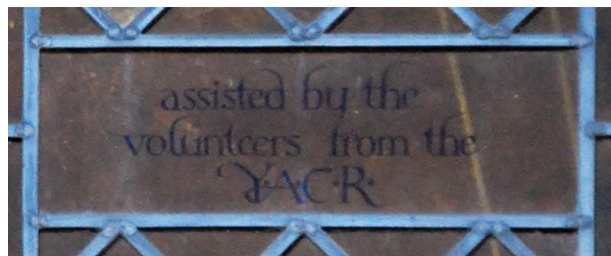
WINDOW NUMBER: Tower, Ringing Room

- The glazing has been recently restored and re-leaded and appears to be in very good condition.

- **General clean in situ (internal only, where access available).**
