Care of Churches and Ecclesiastical Jurisdiction Measure 1991 – Quinquennial Inspection **ALL SAINTS, THIRKLEBY - GRADE II***

York Cleveland 643 602

29th Sept 2023

Studio Tamacoco Architects

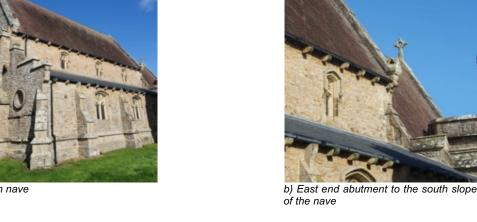
a) South nave

- 2.4.1 The south slope of the nave is covered in red clay tiles and identical to the north slope except that the fish scale tiles are also red rather than black. The condition of the tiles is also very similar with a couple of chipped corners here and there but nothing that affects the weather tightness of the roof or requires remedial work.
- What is of concern is the condition of the coping stones, especially the apex stone on 2.4.2 the west gable. Drone footage taken to investigate a potential leak on the south aisle in December 2022 captured a bird's eye view of the copings and the apex stone appears to have a significant fracture across the middle of its top surface. This item needs to be inspected in detail from a cherrypicker by a specialist stonemason as part of the recommendation made elsewhere in this report for masonry investigations.
