# **THE INSPECTION OF CHURCHES MEASURE 1955**

### **REPORT AND RECOMMENDATIONS**

**CHURCH OF ALL SAINTS, THIRKLEBY**

**INSPECTED ON 3<sup>RD</sup> APRIL 2018 BY**

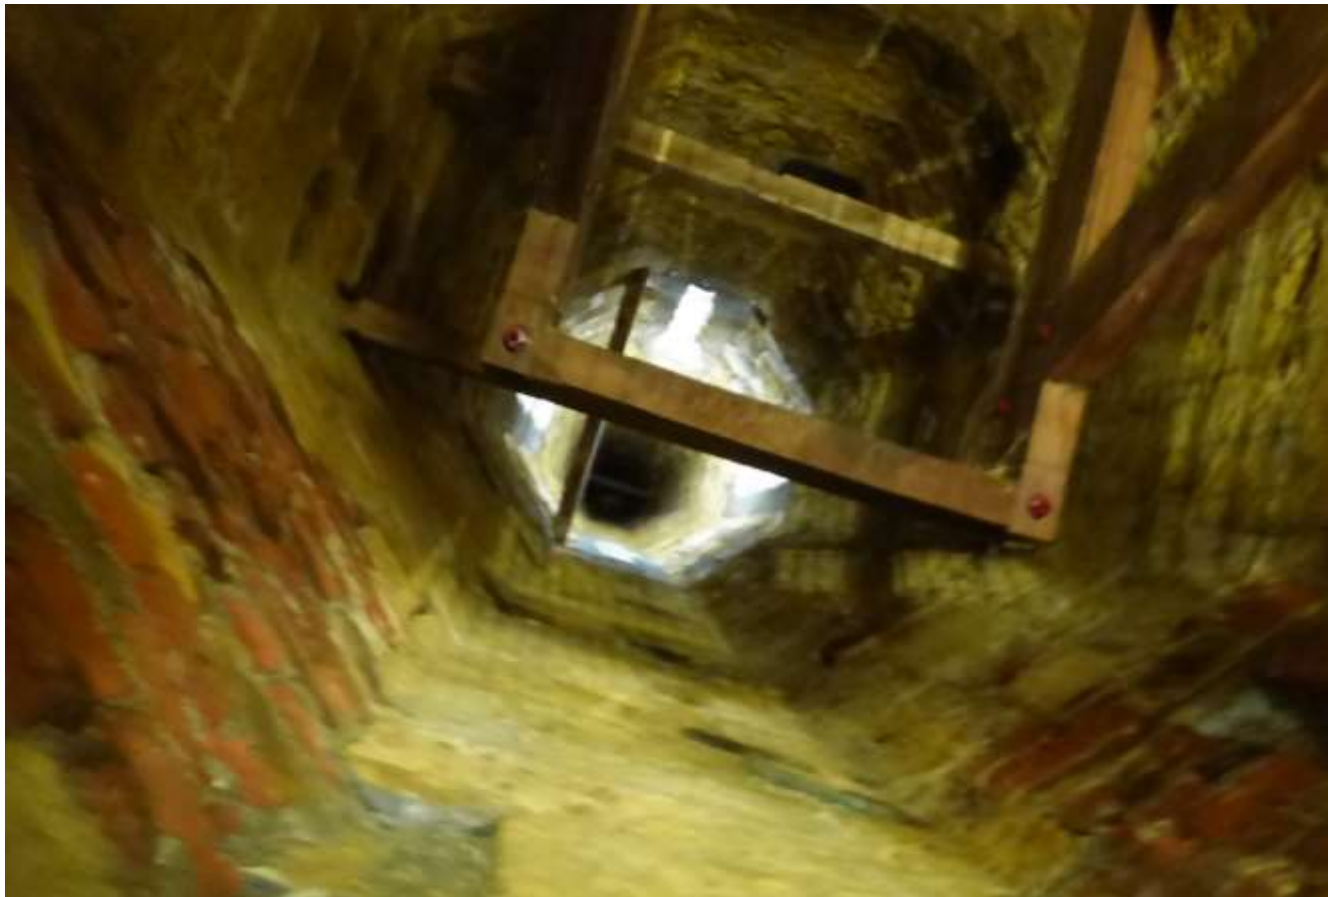
The spire (and other parts of the church) are known to contain wrought iron cramps. The stone and brick on the inside of the spire is very eroded and some of the external stonework has deteriorated since the last inspection. There is also evidence of past cement patch repairs to the stone faces. A condition report should be commissioned from a steeplejack to inform any repair work.

8. Internal view of spire.

- Steeplejack to undertake inspection of spire and lady chapel and porch roofs and prepare condition report to inform any repair works.
- Make safe cover to boiler room steps.
- Heating engineer to check overflow to header tank and boiler flue.

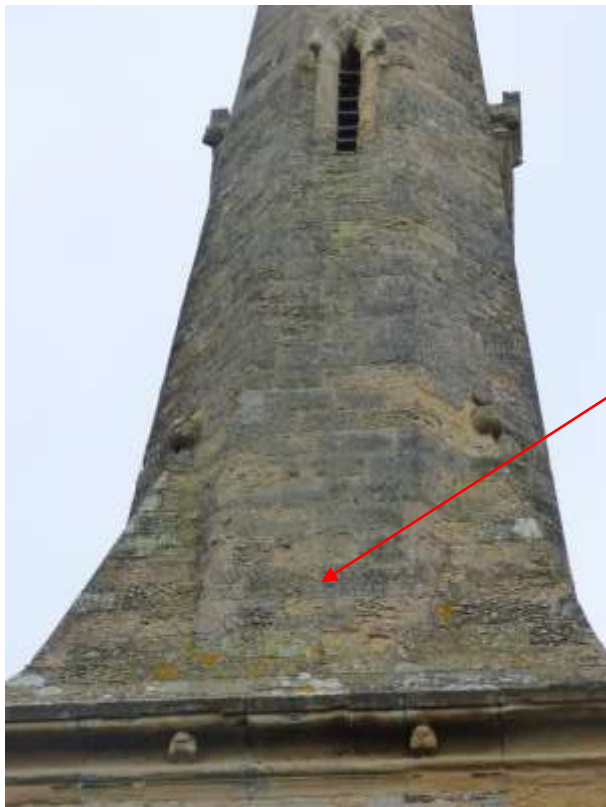
10. General view of west side of spire.

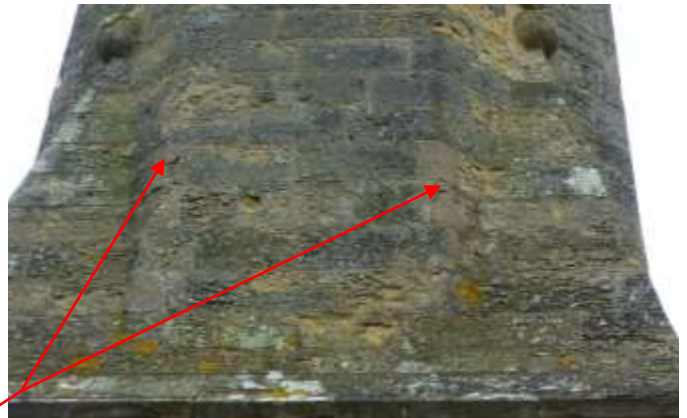
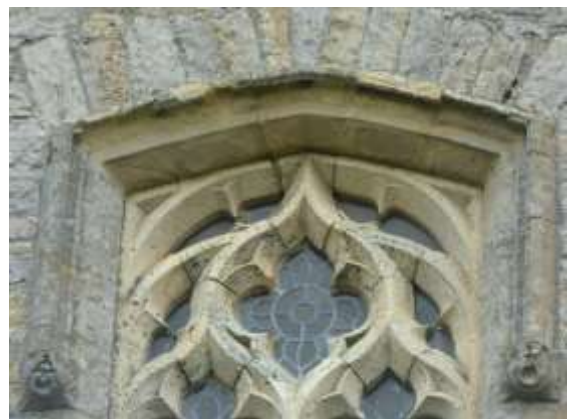
| | | between the window and the head of the spire and some of lower stones have been buttered over in cement which is cracked and loose. Jamb stones to slit opening eroded. Stonework from the slit opening down to the cornice moulding is weathered and eroded in places. Cornice moulding, open jointed and weathered, ball flowers disfigured. | F/O C/D |

11. Close views of decayed stonework to base of spire and window.

- Stone repairs and repointing to high level areas including spire and window stonework (in conjunction with any glazing repairs subject to specialist recommendations).

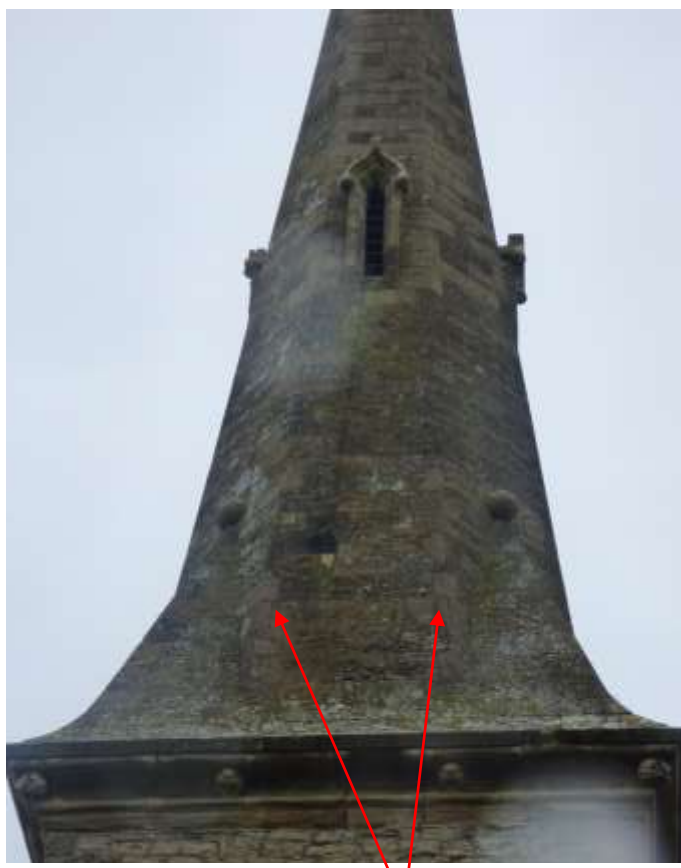
12. Further evidence of past cement patch repairs to base of east side of spire.

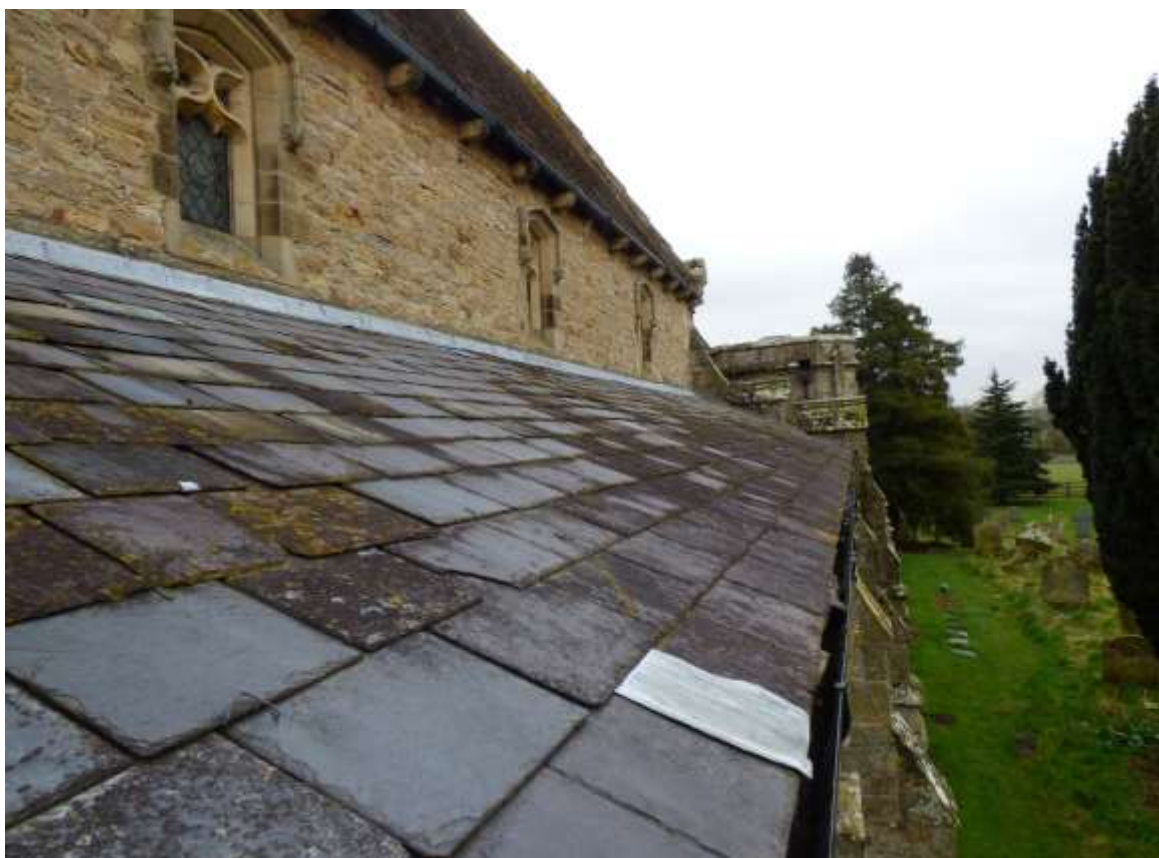
The slating on the south aisle and vestry roofs show many tingle repairs (due to nail fatigue) and there is damp ingress internally. It is recommended that the condition of the slates and fixings is investigated further. But I suspect if the roofs coverings are original to the church i.e. 1851 then these will now need recovering. With careful maintenance it may be possible for the roofs to limp along for a few more years. However, you may find the frequency of repairs will increase and it will be uneconomic to keep on repairing them. Some minor repairs are needed to the remaining roofs.

| | 55. Roof coverings: many lead and copper tingle repairs, slates with corners out and some which are split through the tails which all indicates the roof coverings have now reached the end of their life. Some moss building up in places. | F/A |

13. General view of south aisle roof.

- Replace slate roof coverings to south aisle and vestry roofs.
- Carryout repairs to remaining roofs. Carefully sweep off and remove moss from slates/tiles.
- Repair, overhaul and redecorate cast iron rainwater goods; interior of gutters should be coated with bitumastic paint to extend their life.
- Renew timber duck boards to valley gutter over north aisle roof between nave and tower.
- Stonemason to check high level copings and corbel stones and make safe.
- Renew cover to boiler room steps.
- Independent timber specialist to investigate woodborer activity and advise on treatment works.
- Renew mortar flashings to abutment in lead.
- Upgrade belfry ladders.

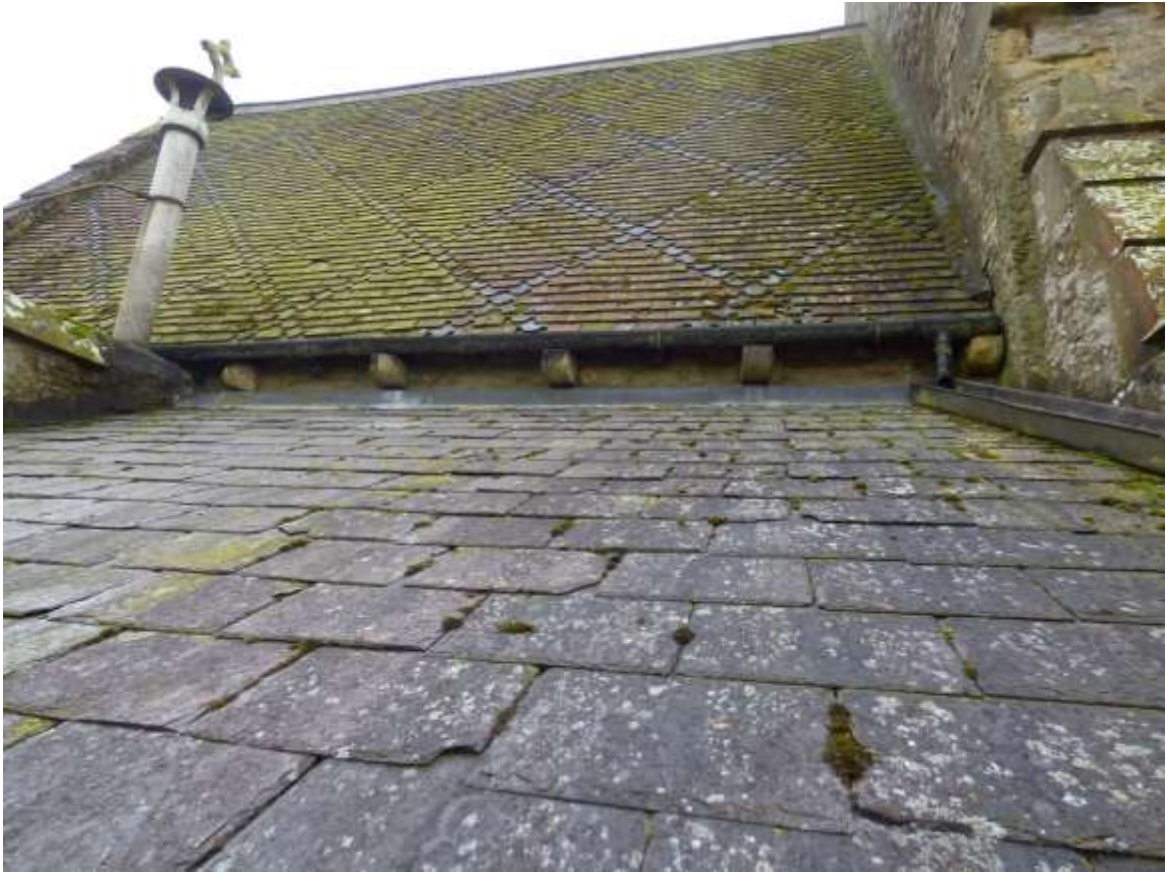
| | 49. Roof coverings: 1no slate which has slipped upper left side. 1no lead tingle repair which is turning back and 1no slate with corner out. Otherwise slating in order. Bituminous reinforced slaters felt visible in the gutter (which indicates the roof has been re-slatted in say the last 25 years). Felt decayed slightly at the west end. | A |

14. General view of vestry roof.

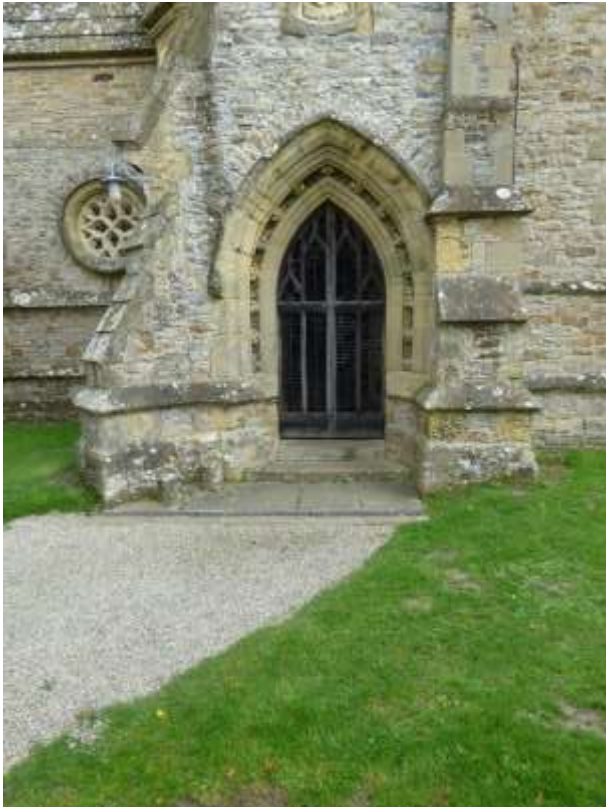
15. General view of west doorway.

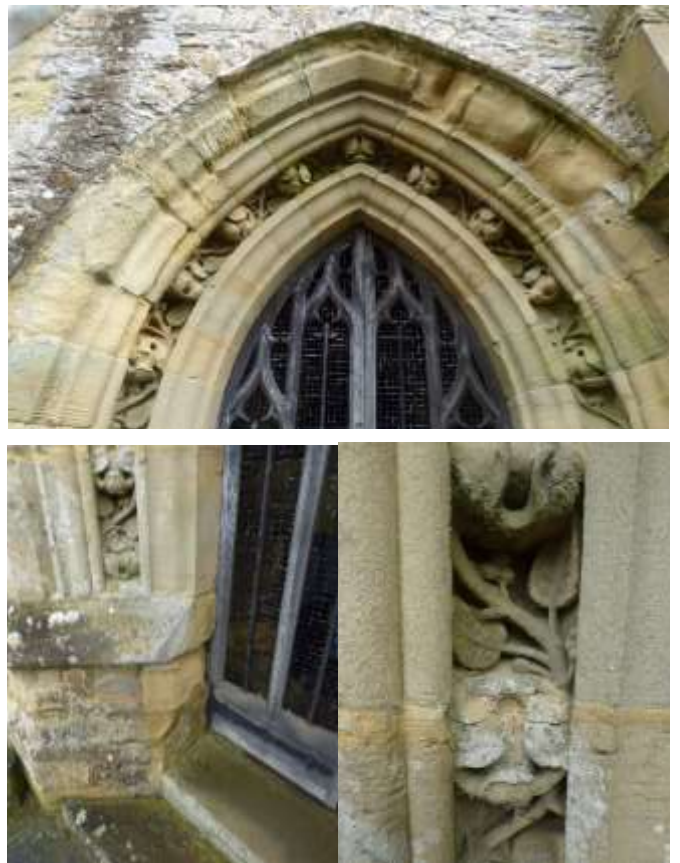
The stonework to the lower parts of the church is variously eroded particularly the south and west sides which will take the brunt of the prevailing wind and rain. This will need some attention within the next quinquennium. The west porch doorway and date stone would benefit from some conservation repairs.

16. General views of decay to west doorway.

- Anticipate further stone repairs and repointing to main walls (using lime mortar).
- Carryout stone conservation works to west porch doorway and date stone.

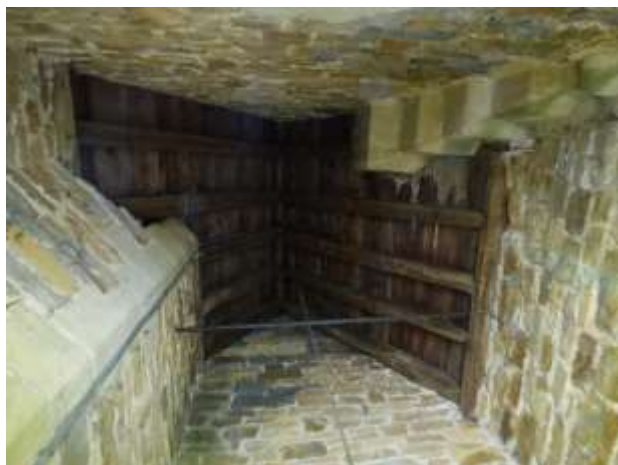
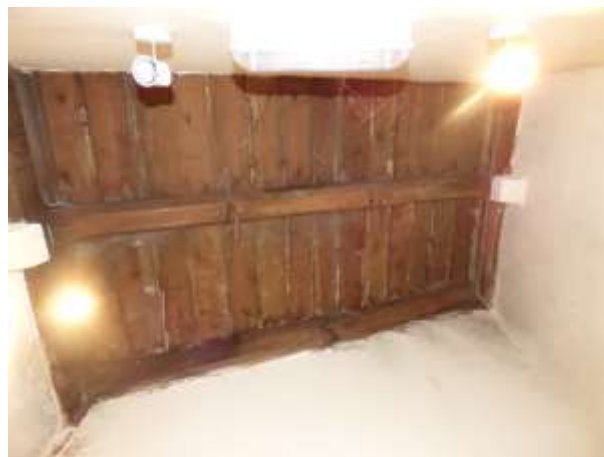
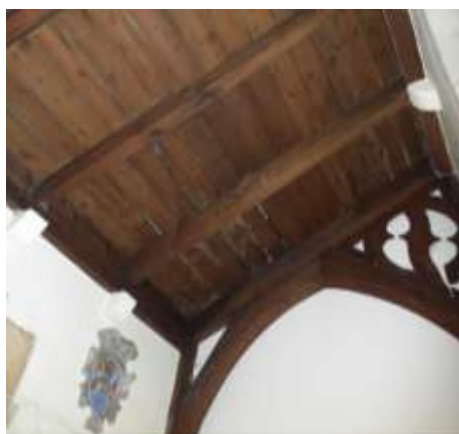
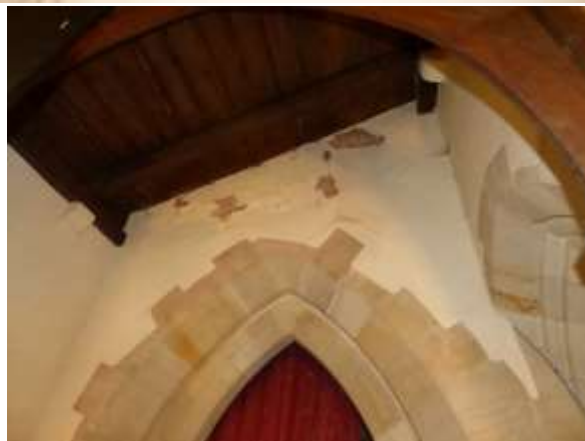
20. Damp ingress to underside of roofs, clockwise from top left: south side of porch; toilet; east end of north aisle; west end of south aisle.

- Dampness to ceilings, walls (including column bases) and floors as noted in main report.
